# LAKE WINNISQUAM WATERSHED-BASED PLAN

**PREPARED BY FB ENVIRONMENTAL ASSOCIATES & HORSLEY WITTEN GROUP**  
*in cooperation with the Winnisquam Watershed Network, the New Hampshire Department of  
Environmental Services, and the US Environmental Protection Agency*

JULY 2022 | **FINAL**

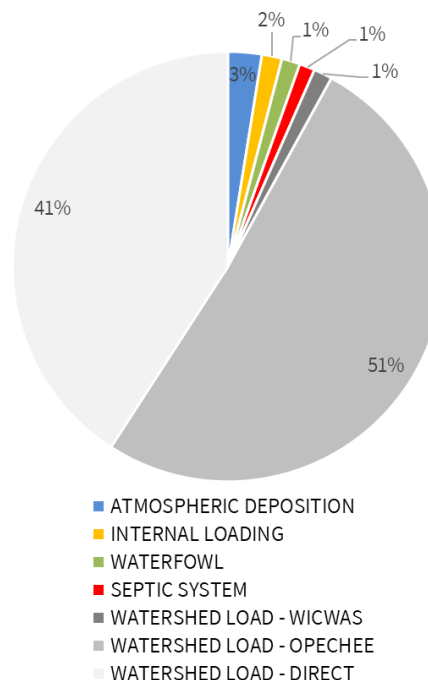
**Figure 8.** Summary of total phosphorus loading by major source for Lake Winnisquam. Refer to Table 6 for a breakdown.

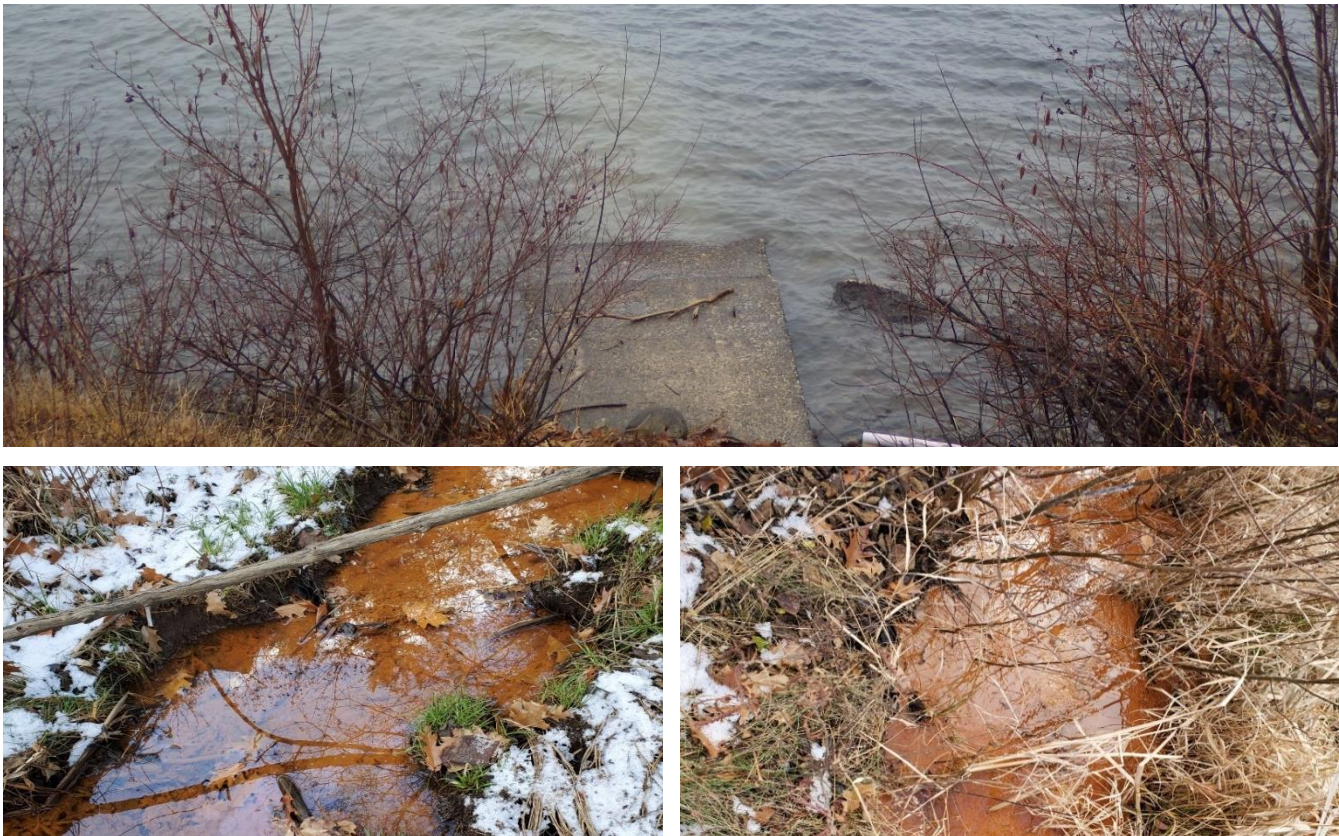
(TOP) Outflow from retention pond into Lake Winnisquam following a rain event. (BOTTOM LEFT) Rusty color and oil sheen flowing in Hueber Brook. (BOTTOM RIGHT) Rusty colored flow from small watercourse parallel to Sun Lake Drive.

Recommendations: Improve stormwater controls through the construction and implementation of stormwater runoff treatment measures, such as bioretention cells.

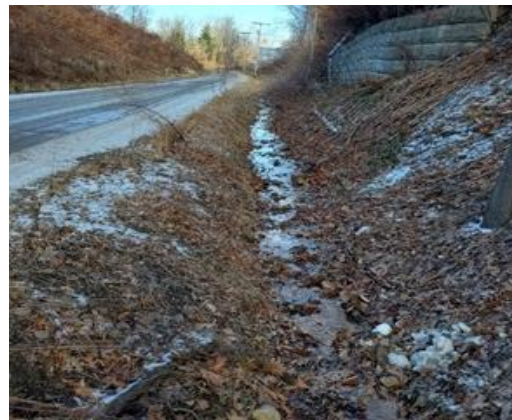
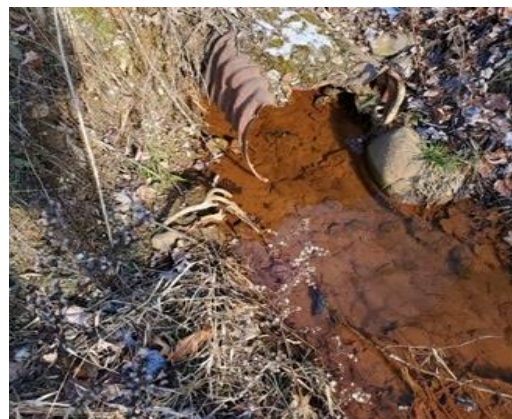
**(4) FAILING CULVERTS THROUGHOUT HUEBER BROOK DRAINAGE AREA**

Observations: Multiple culverts within the drainage area were observed to be failing. Failures included rust, blockages, and algae build up.

Recommendations: Replace culverts.

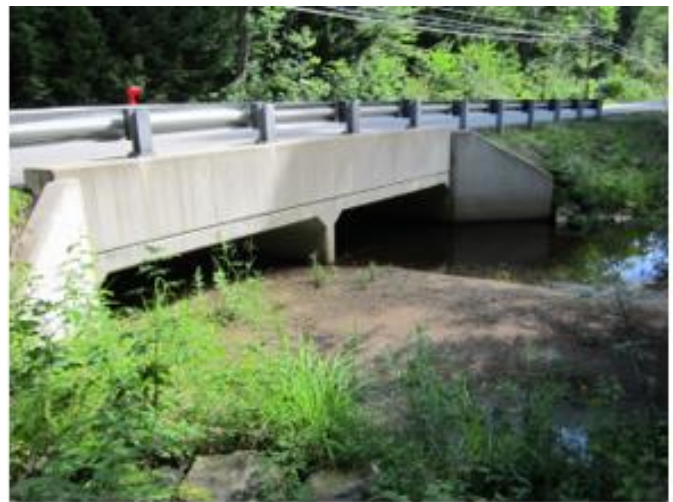
Sedimentation evident at a new box culvert along Black Brook at the Black Brook Rd crossing. Photo courtesy of Lang (2021).

In 2021, BCCD hired an engineer (G. Lang, P.E.) to review and assess environmental issues affecting the water quality of Black Brook with emphasis on assessing the cause of sedimentation altering flow conditions at a newly installed box culvert at the Black Brook Rd crossing. Previous studies reviewed in preparation for the field assessment included the 2012 *Black Brook Watershed Management Plan* (AECOM, 2012) and the 2020 *Summary and Final Documentation, Sanbornton Roadway Evaluation* (Underwood Engineers, Inc., 2020). Lang (2021) found sediment loading issues coming from Huse Road, Kaulback Road, Woodman Road, and Black Brook Road. Lang (2021) also assessed sedimentation at the new box culvert on Black Brook Rd, as well as significant trash and organic material blocking a stop-log structure downstream of the box culvert, and recommended that the stream be surveyed for proper channel grade and backwater effects from the blockage. Lang (2021) recommended that the existing sediment at the box culvert be removed down to the design gravel bottom before opening up the stop-log dam to prevent the sediment from washing into Lake Winnisquam with normal flows restored. A bypass channel may need to be considered to prevent the situation from reoccurring in the future.

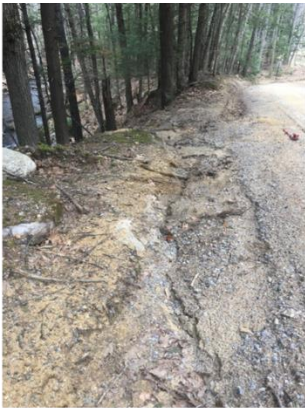
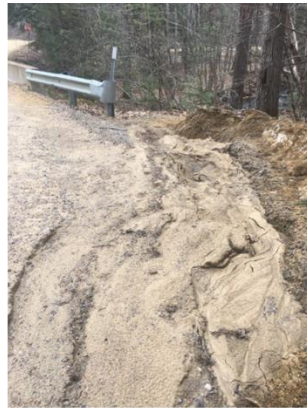
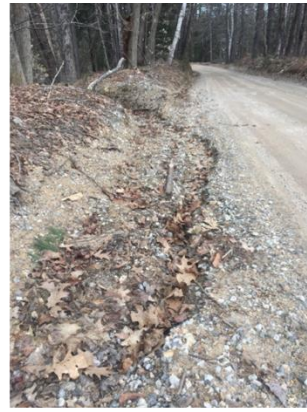
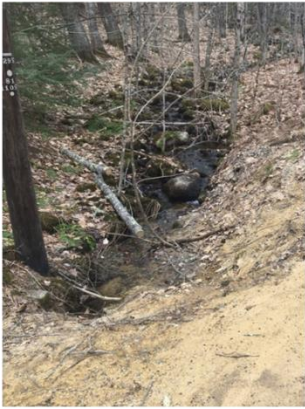
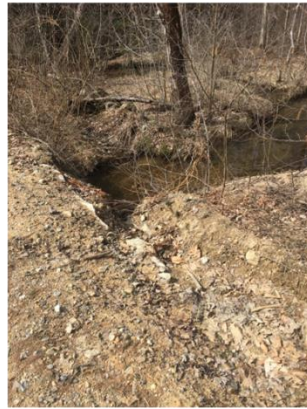
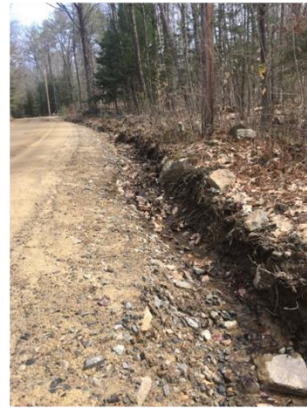
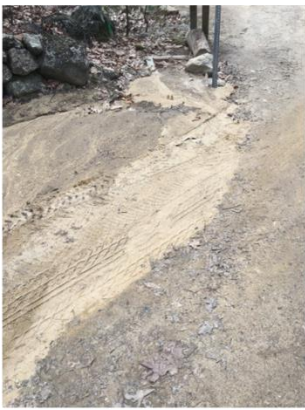
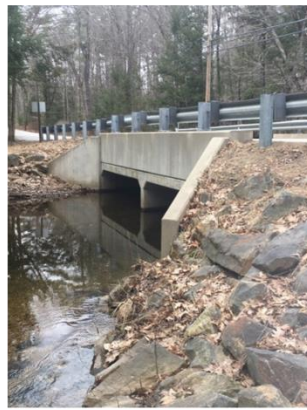
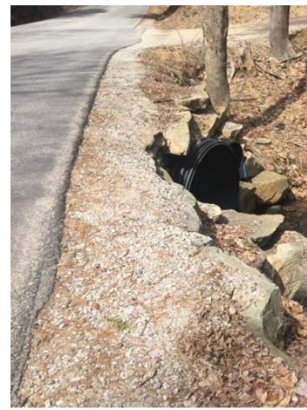
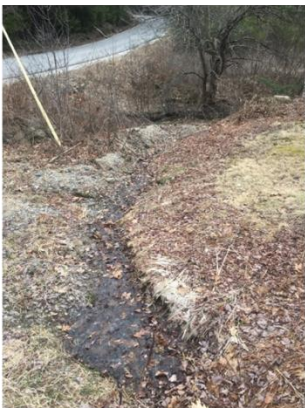
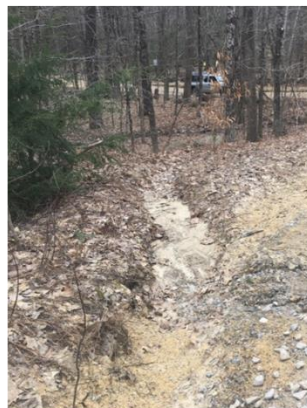
Photos of 11 evaluated and prioritized remediation sites in the Black Brook sub-watershed in Sanbornton. See FBE (2022) for more details. Refer to Figure 12 for site locations.

In 2022, FBE was hired by BCCD to perform a quantitative evaluation of 11 erosion and sedimentation sites in the Black Brook watershed, based on review of sites identified in the 2012 *Black Brook Watershed Management Plan* (AECOM, 2012) and the 2021 *Black Brook Watershed Assessment Update Report* (Lang, 2021). The evaluation results were used to prioritize the 11 sites for implementation and ultimately to serve as supporting documentation for future grant funding applications (site locations identified in Figure 12 and pictured on the next page). During the field visits, FBE evaluated the severity of erosion, collected measurements (length, width, depth) for screening-level erosion volume estimates, noted distance to the nearest surface water, flow condition, and sediment type (silt, sand, and/or gravel), and took representative photos of the sites. These observations were input to the Water Erosion Prediction Project (WEPP) model for estimating pollutant loading from each site. Site prioritization integrated WEPP model results and field observations through a quantitative ranking method (refer to FBE, 2022 for details). The three highest priority sites occurred along Huse Rd where runoff drains to Black Brook south branch, followed closely by Kaulback Rd where most runoff drains to Black Brook north branch. Both roads are unpaved gravel roads on steep slopes, transporting sediment to nearby surface waters.

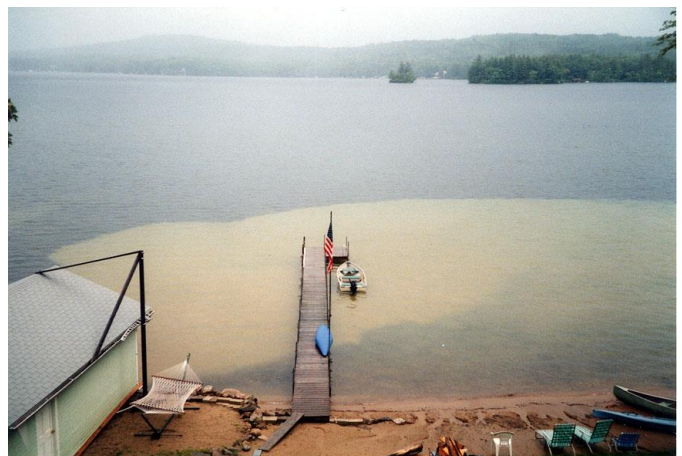
Plume of sediment washing into Lake Winnisquam from Batchelder Hill Rd in Meredith in the 1990s. The problem has since been remediated when the Town paved the road and installed a sediment forebay.

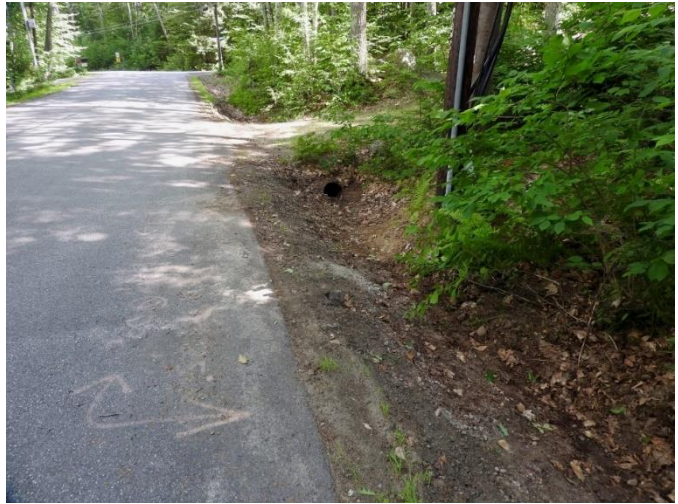
Example of a road ditch with accumulated sediment and vegetation scraped out to maintain hydraulic capacity, as part of the town’s maintenance practices.

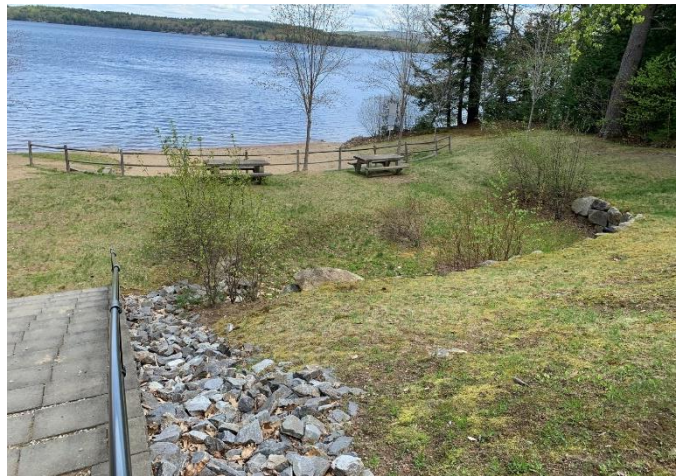
Example of structural BMPs installed at the Sanbornton Town Beach.

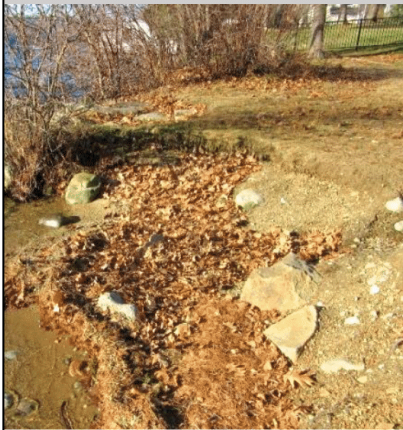
Shoreline of Gale Ave Park.

**Existing Site Description:** Gale Ave Park is a small public park on Lake Winnisquam at the end of Gale Ave in Laconia. The park is accessed from Gale Ave by sidewalks that extend into the park to the south and north. The park features two stone benches and a lawn area. Along the 80-ft shoreline, there is a concrete block remaining from a former wharf, a small, vegetated area, and a small beach-like section that slopes down to the water. The Laconia Department of Parks and Recreation is developing plans for a shoreline retaining wall, an accessible paved path, and a kayak launch. Stormwater runoff from Gale Ave and adjacent residential properties appears to bypass storm drains along Gale Ave and flow into shallow swales along the north and south edges of the park. Further investigations are needed to determine the cause(s) and amount of bypass. The swales are significantly eroded, particularly at the end of the swale to the south. A drainage outfall is located to the north of the park. A sanitary sewer extends from Gale Ave into the park, where there are two sewer manholes. Soils at the site are categorized as hydrologic soil group (HSG) C, indicating moderate infiltration capacity.

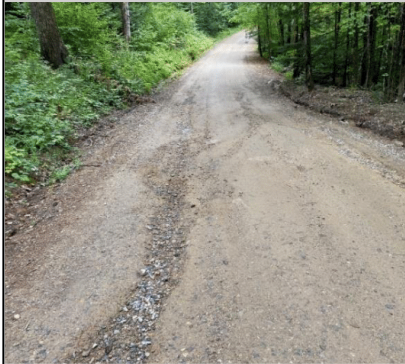
Erosion along Kaulback Road.

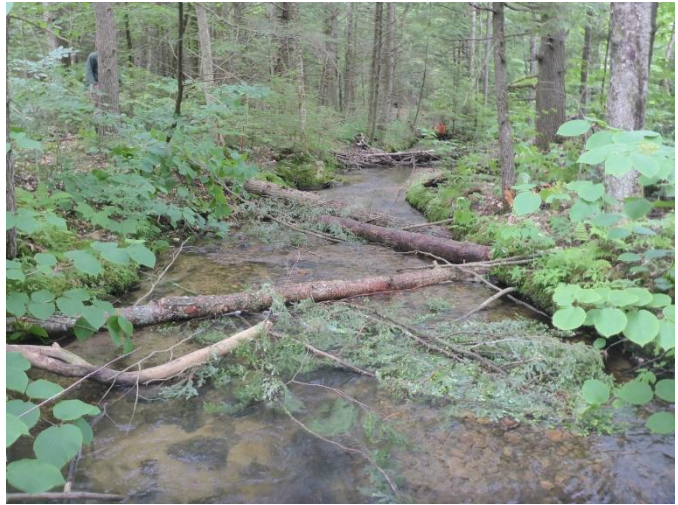
The felling of large woody material was completed in a one mile segment of Black Brook as part of a stream habitat restoration project in 2021 by the BCCD and Trout Unlimited.

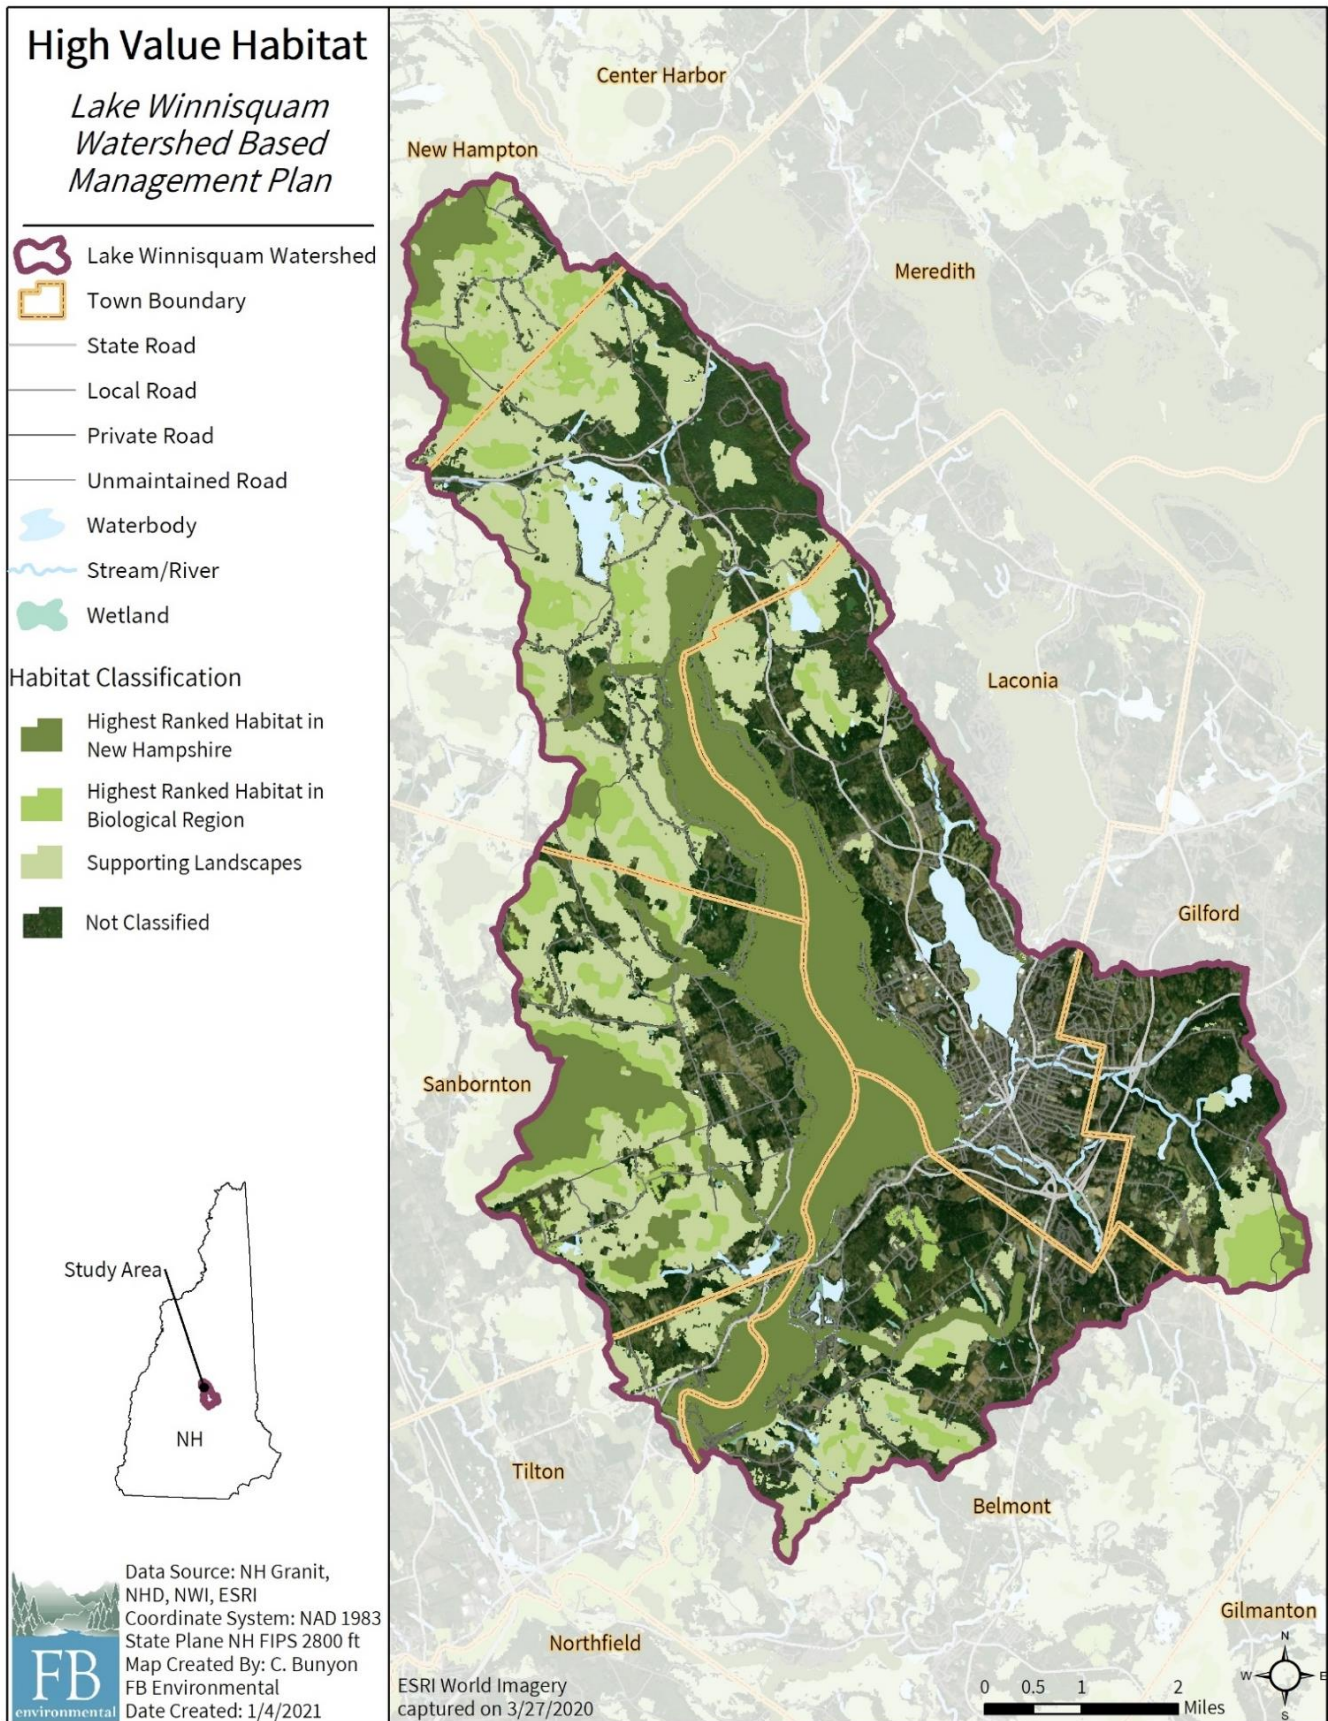
Map B-10. High value habitat according to the 2015 New Hampshire Wildlife Action Plan in the direct Lake Winnisquam watershed.
